TS-PIC-89108
February 1990

Site Analysis Tidewater Baling Newark, New Jersey

EPA Region 2
and OERR

Site Analysis
Tidewater Baling
Newark, New Jersey

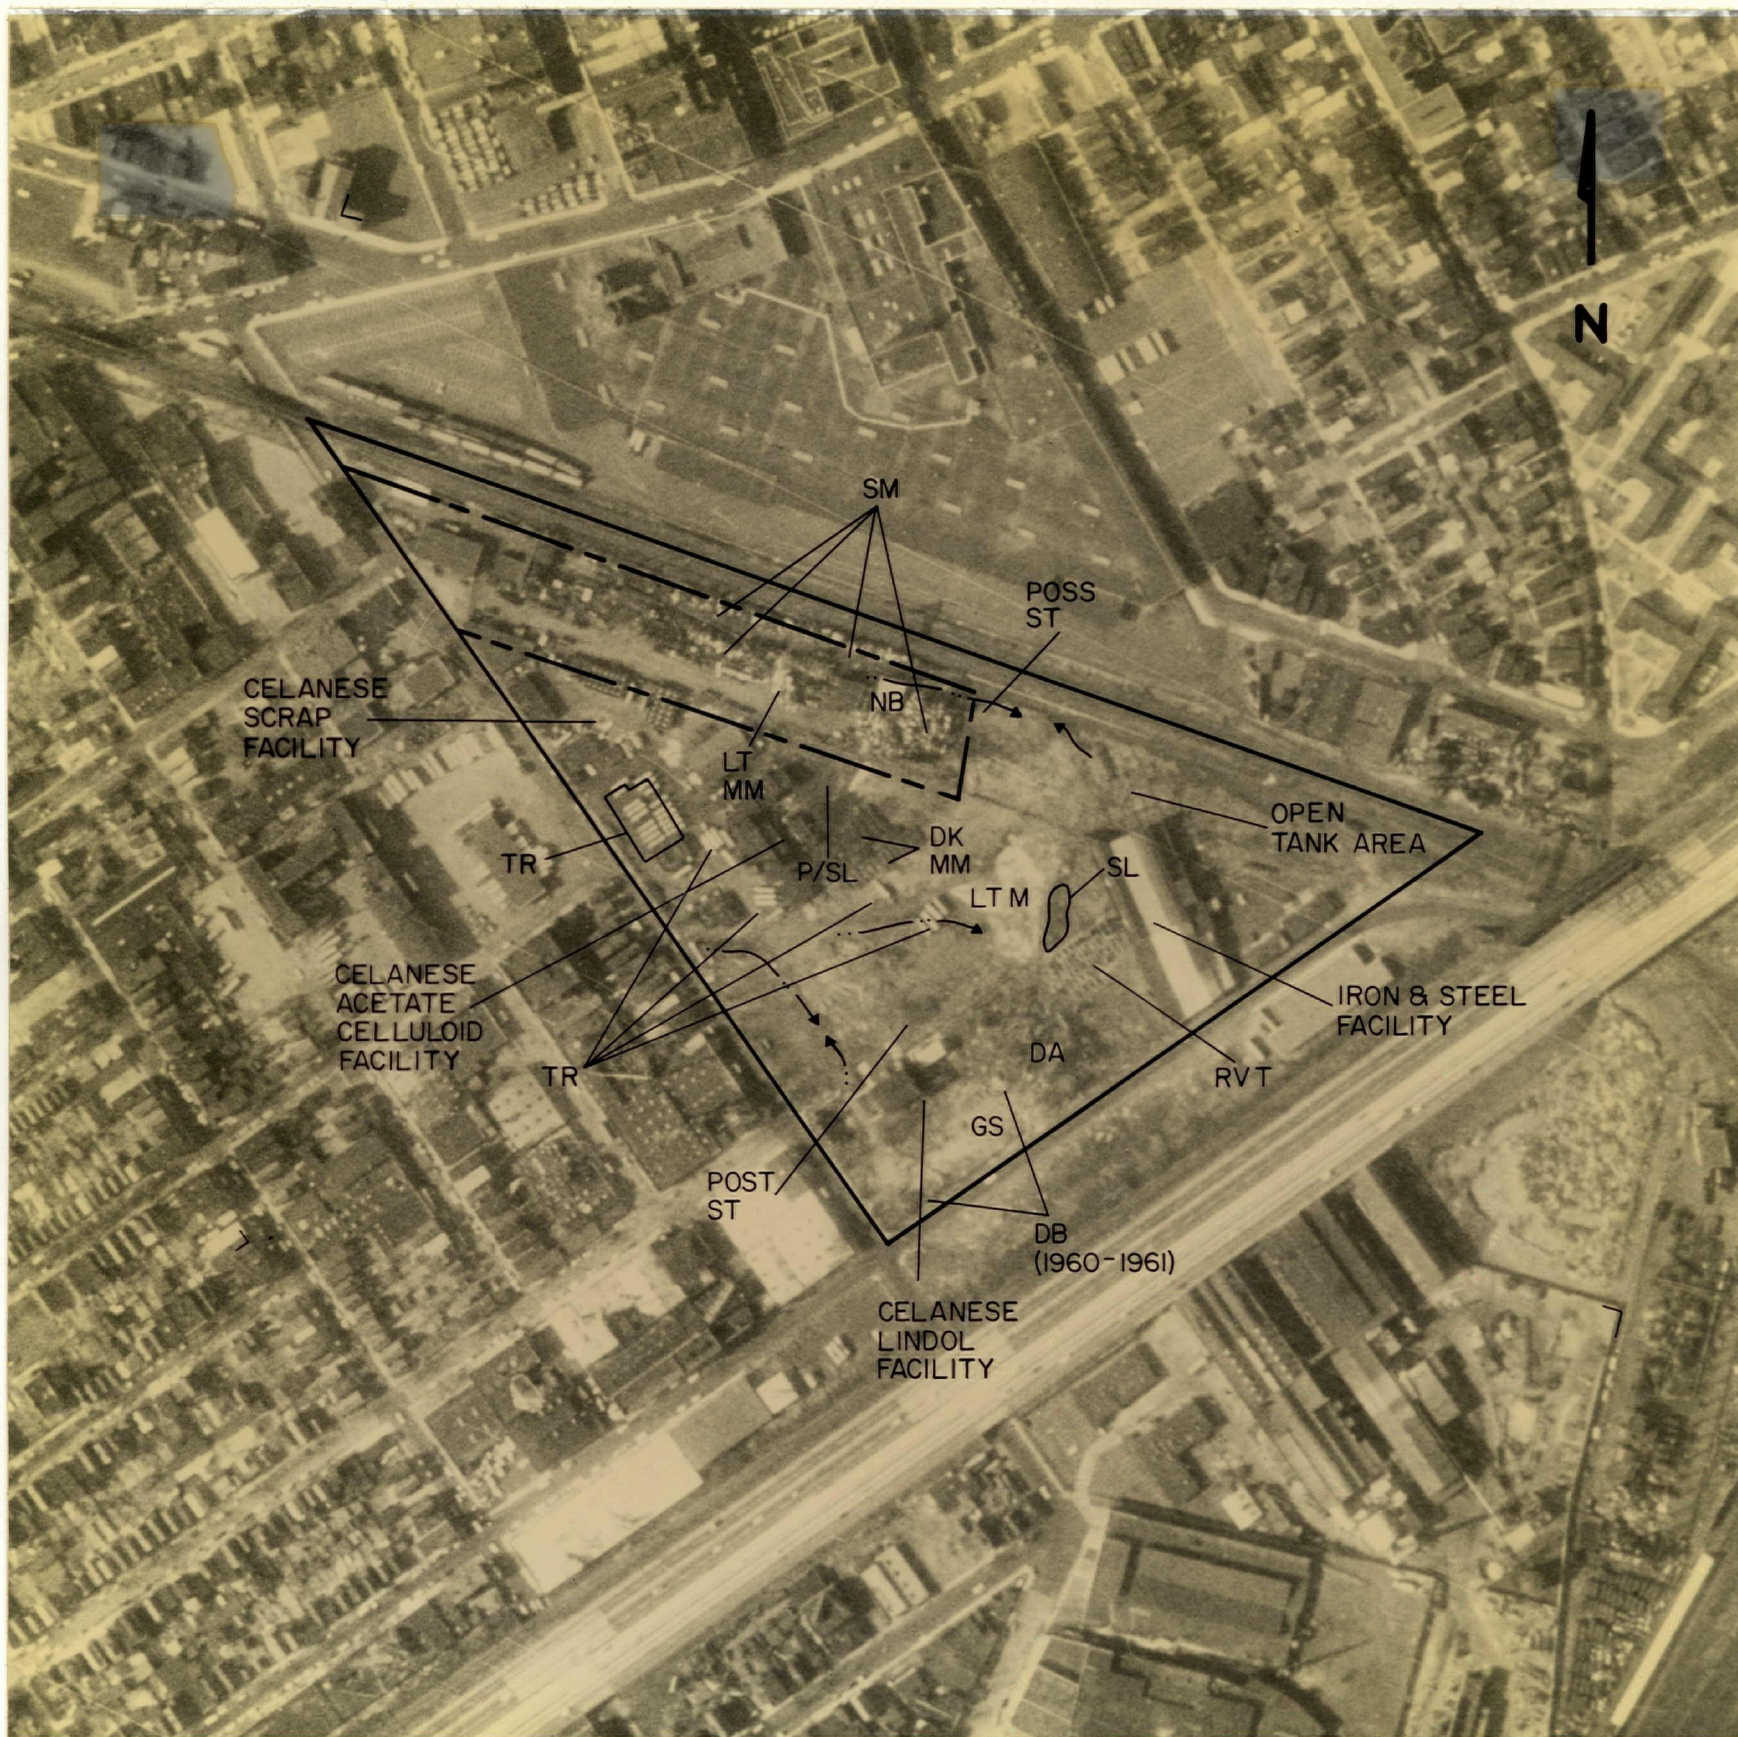
FIGURE 5
TIDEWATER BALING

In the western section of Tidewater Baling, miscellaneous scrap and containers (not annotated) are spread out into low piles. Four large mounds of rough-textured, possibly rectangular, dark- and light-toned scrap materials are visible to the east. A new building is present. A small mound of light-toned, fine-textured material is seen west of the new building. The area between the four large mounds in the northeastern portion of the site appears stained (not annotated).

A group of linear mounds composed of fine-textured, dark-toned materials is visible in the Celanese Acetate Celluloid Facility. Staining (similar in tone to the mounded materials) is noted throughout the northern portion of this facility. A pit with standing liquid is present north of the Celanese Acetate Celluloid Facility.

West of the Celanese Acetate Celluloid plant is a large group (outlined) of trailers (TR). Four probable tank-trailers (not annotated) are located in the eastern corner of this group. Several other trailers are seen to the east. In the field area, light-toned material is visible (as in 1959 and 1963) near a group of trailers. A ground stain (not annotated) is located east of these trailers. A pool of standing liquid is present immediately east of the light-toned material.

A possible stain is noted north of the Celanese Lindol Facility. Debris was noted near the southeastern study area boundary in 1960 and 1961, as it was in 1959. The area also contains a large ground scar and a mottled dark- and light-toned disturbed area. No significant activity or change is noted at the Iron and Steel Facility at this time.

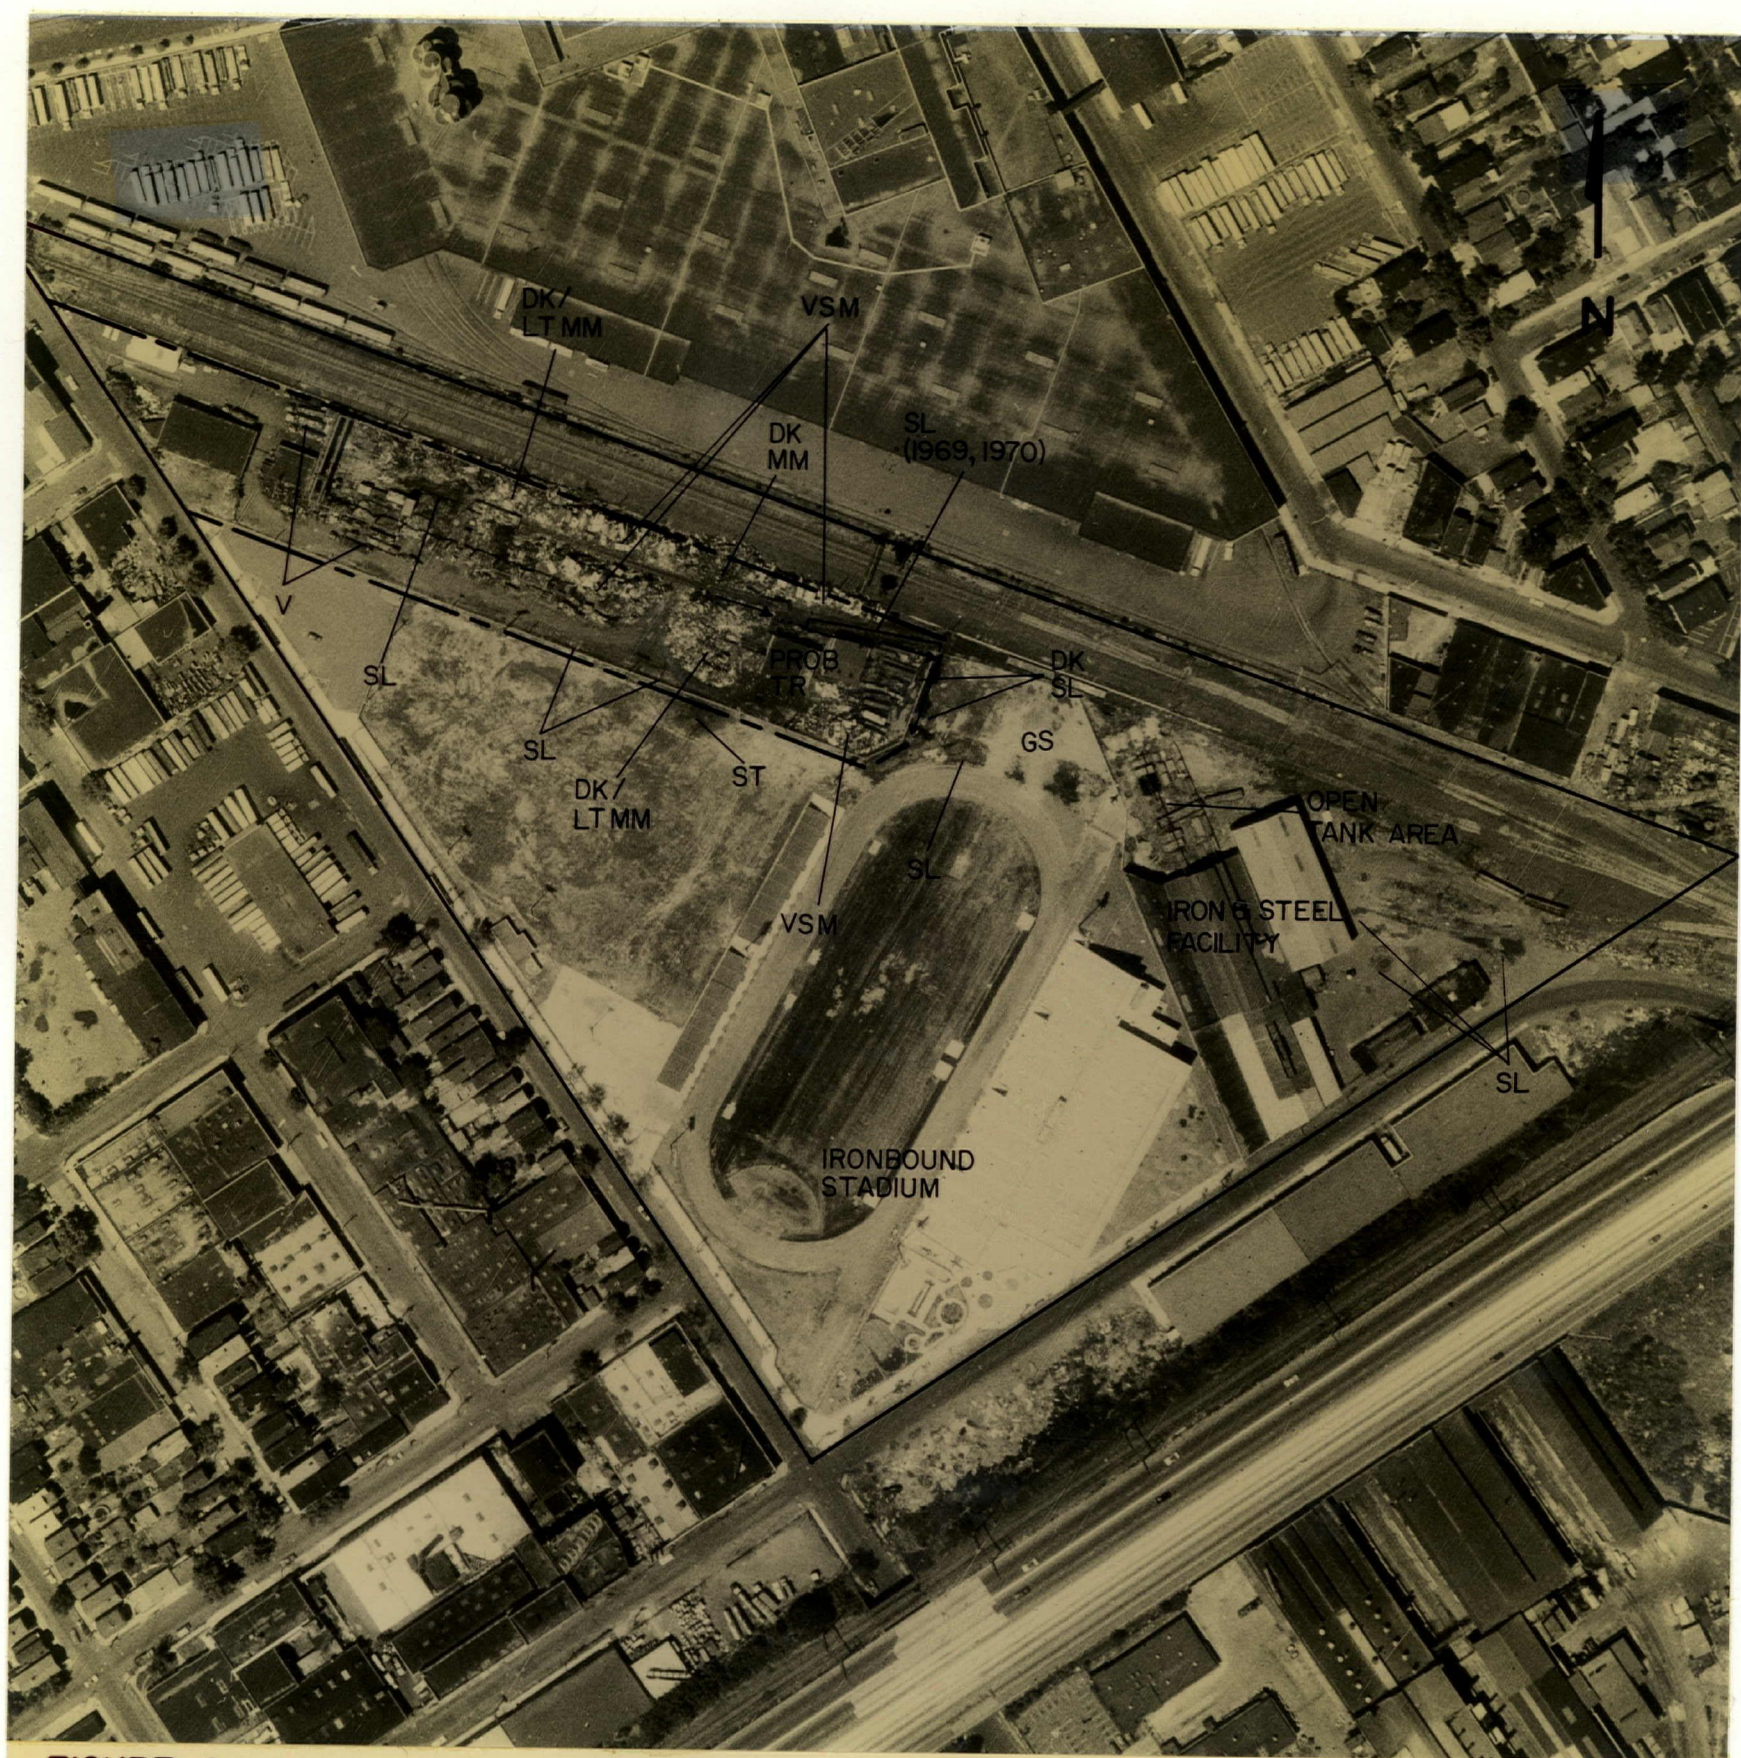
FIGURE 6
TIDEWATER BALING

Several major changes have occurred. The Celanese facilities and the revetted tank area are no longer present (last seen in 1969). Ironbound Stadium has been constructed on the southeastern portion of the Celanese properties. Playing fields are present in the central field area. A parking lot has been constructed at the former location of the Celanese Scrap Facility. A sharp vertical drop in elevation now occurs between Tidewater Baling and the field areas to the south and east.

The western portion of Tidewater Baling contains a small amount of scrap material (not annotated). Two mixed light- and dark-toned mounds of rough-textured material are present. Four mounds composed primarily of vehicle scrap materials (VSM) are present. Several probable trailers are also noted. Stains (not annotated) are visible around the mounded materials and scrap.

Numerous pools of standing liquid within the study area are probably due to a recent rainfall. However, two areas of standing liquid are noteworthy due to their darker tone and location. A ditch containing dark-toned liquid is present immediately east of the site boundary, beyond the fence, and below the drop in elevation. An area of dark-toned standing liquid is also noted within the site boundary, just west of the ditch. A large ground scar is visible east of this area.

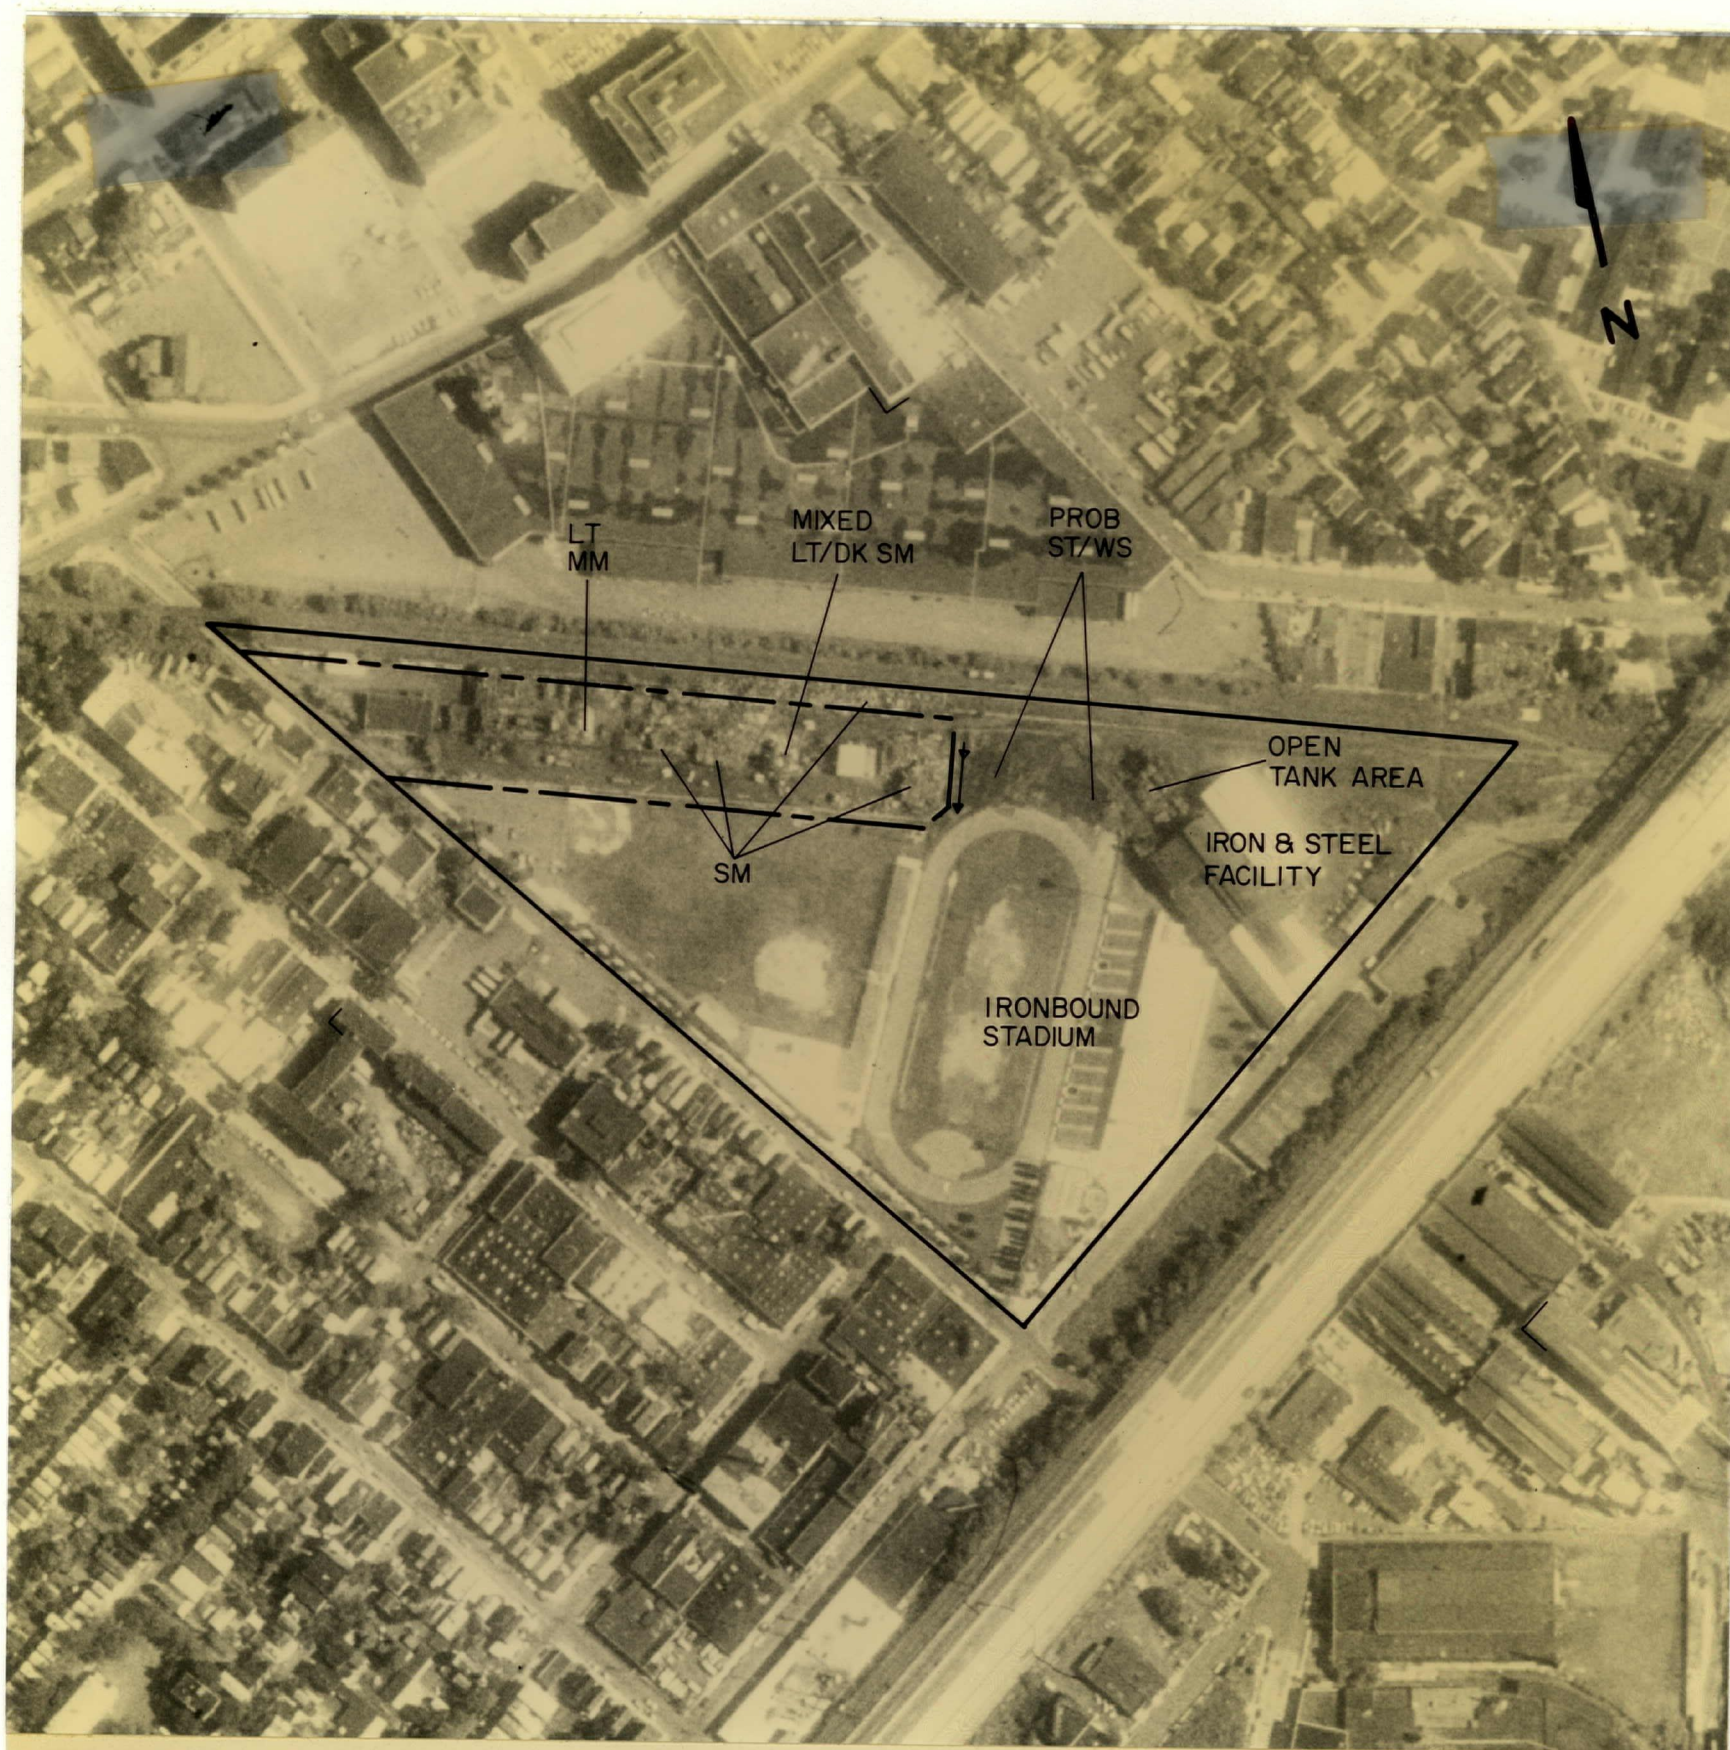
FIGURE 7
TIDEWATER BALING

A light-toned mound of fine-textured material is located in the western portion of the Tidewater Baling site, among scattered debris and equipment. Four large scrap material mounds composed of medium-toned, homogenous, nearly rectangular objects are visible. The northern mound is linear and extends onto the rail line. A mixed light- and dark-toned mound of scrap material composed of large, irregular objects is present. A large probable stain/wet soil area is present east of the Tidewater Baling site and just west of the open tank area.

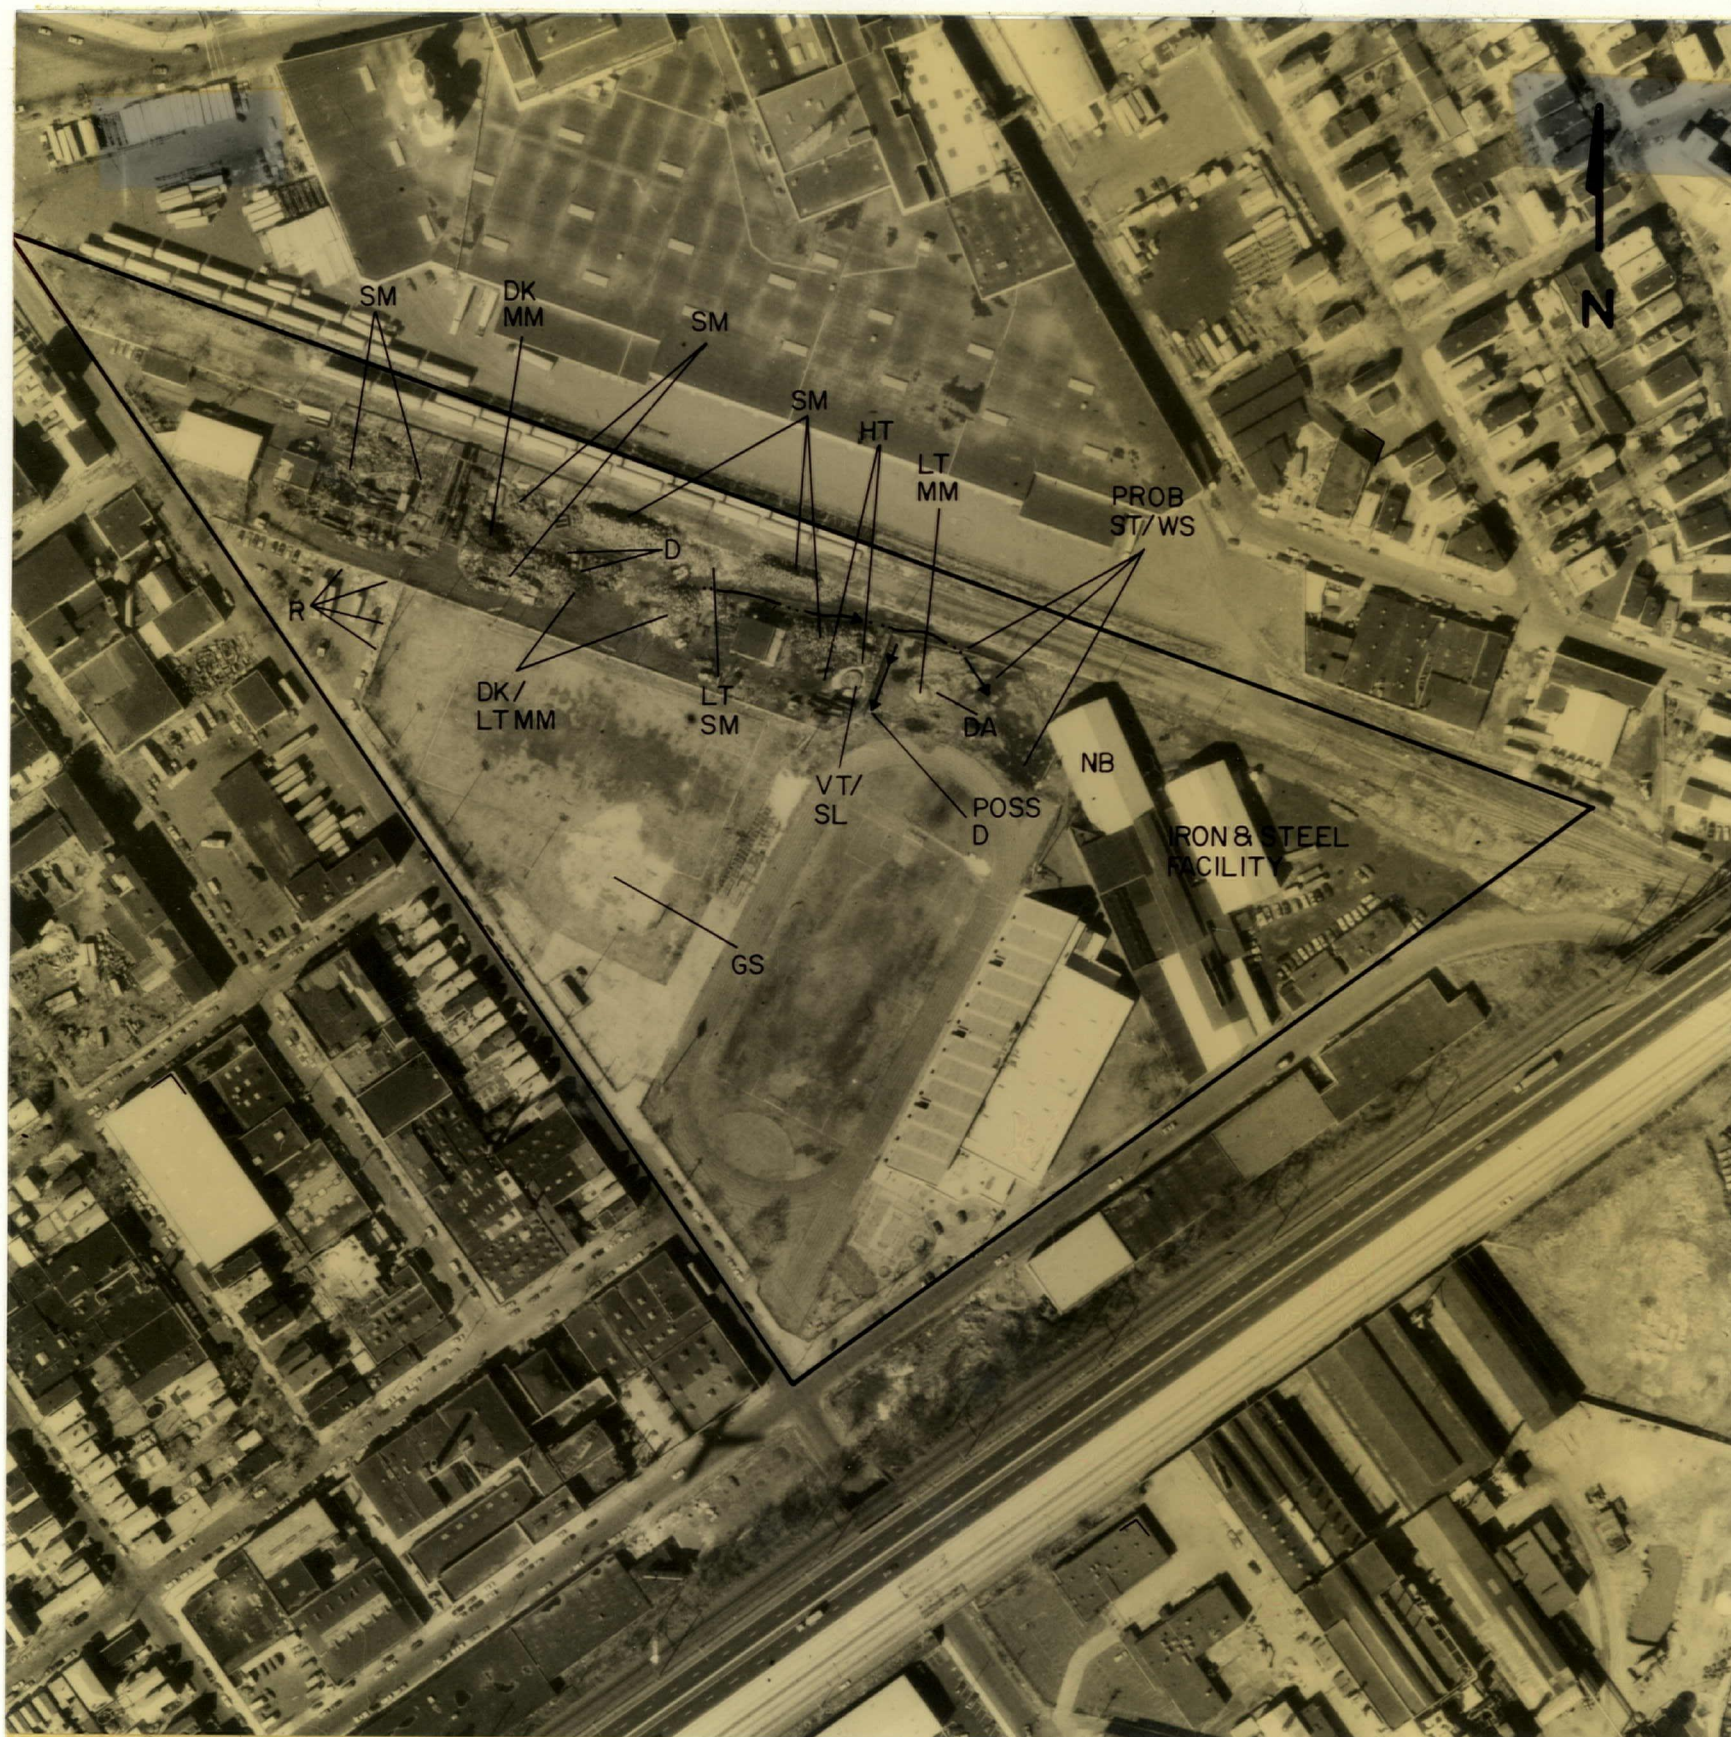
FIGURE 8
TIDEWATER BALING

The western stands have been removed from the stadium area. A new building has been constructed northwest of the Iron and Steel Facility, on the site of the pre-existing open tank area (1959-1970).

Refuse (R) is present in the parking lot adjacent to the Tidewater Baling Facility. Medium- to light-toned mounded scrap materials are present in the northwestern portion of the Tidewater Baling facility. Vehicles and equipment (not annotated) are visible here as well. A dark-toned, fine-textured mound of material is present southeast of the mounded scrap materials. A group of approximately 18-20 drums (D) is present in the central portion of the site. Two piles of scrap materials are present here as well. Two mounds of dark- and light-toned scrap material are present in the central area. A mound of light-toned scrap material is also seen here. Three large, homogenous mounds of medium-toned, rectangular scrap materials are visible to the east.

Several horizontal tanks and a vertical tank containing light-toned liquid are present. The vertical tank is elliptical and is surrounded by light-toned material, which may have been the result of a leak or spill. A thin element of this light-toned material area extends north alongside the aforementioned horizontal tanks. A large probable stain/wet soil area extends from the central portion of the site boundary area to an area northeast of the stadium field. Other smaller probable stain/wet soil areas (not annotated) are present northwest of the stadium, within the ditch and around a possible drum. Northeast of this possible drum is a mound of light-toned material, surrounded by a disturbed area. The fence (not annotated) north of this area, which is south of the Tidewater Baling rail spur (not annotated), has been removed. A ground scar is found in the southwestern portion of the study area.
